Petrovskoye Field Subsurface Diagnostics

Remote Geospace Survey Results &
Final Investment Recommendation

Target Area: Petrovskaya Well #2 (Radius 1.5km)
Survey Area: 2.25 sq km (Saratov Region)
Contract Code: Saratov-1 (1-10-20)

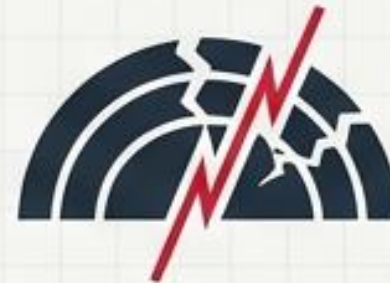
Broken Structural Integrity:

Tectonic faults directly intersect both identified anomalies, destroying the necessary geological traps.

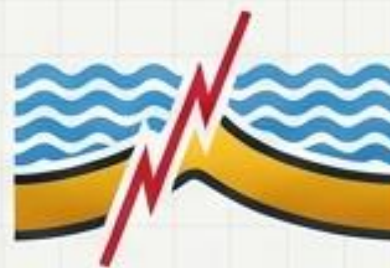
Water Flooding Risk:

The presence of migrating fluid flows through the broken faults introduces an unacceptable risk of water breaching the reservoir.

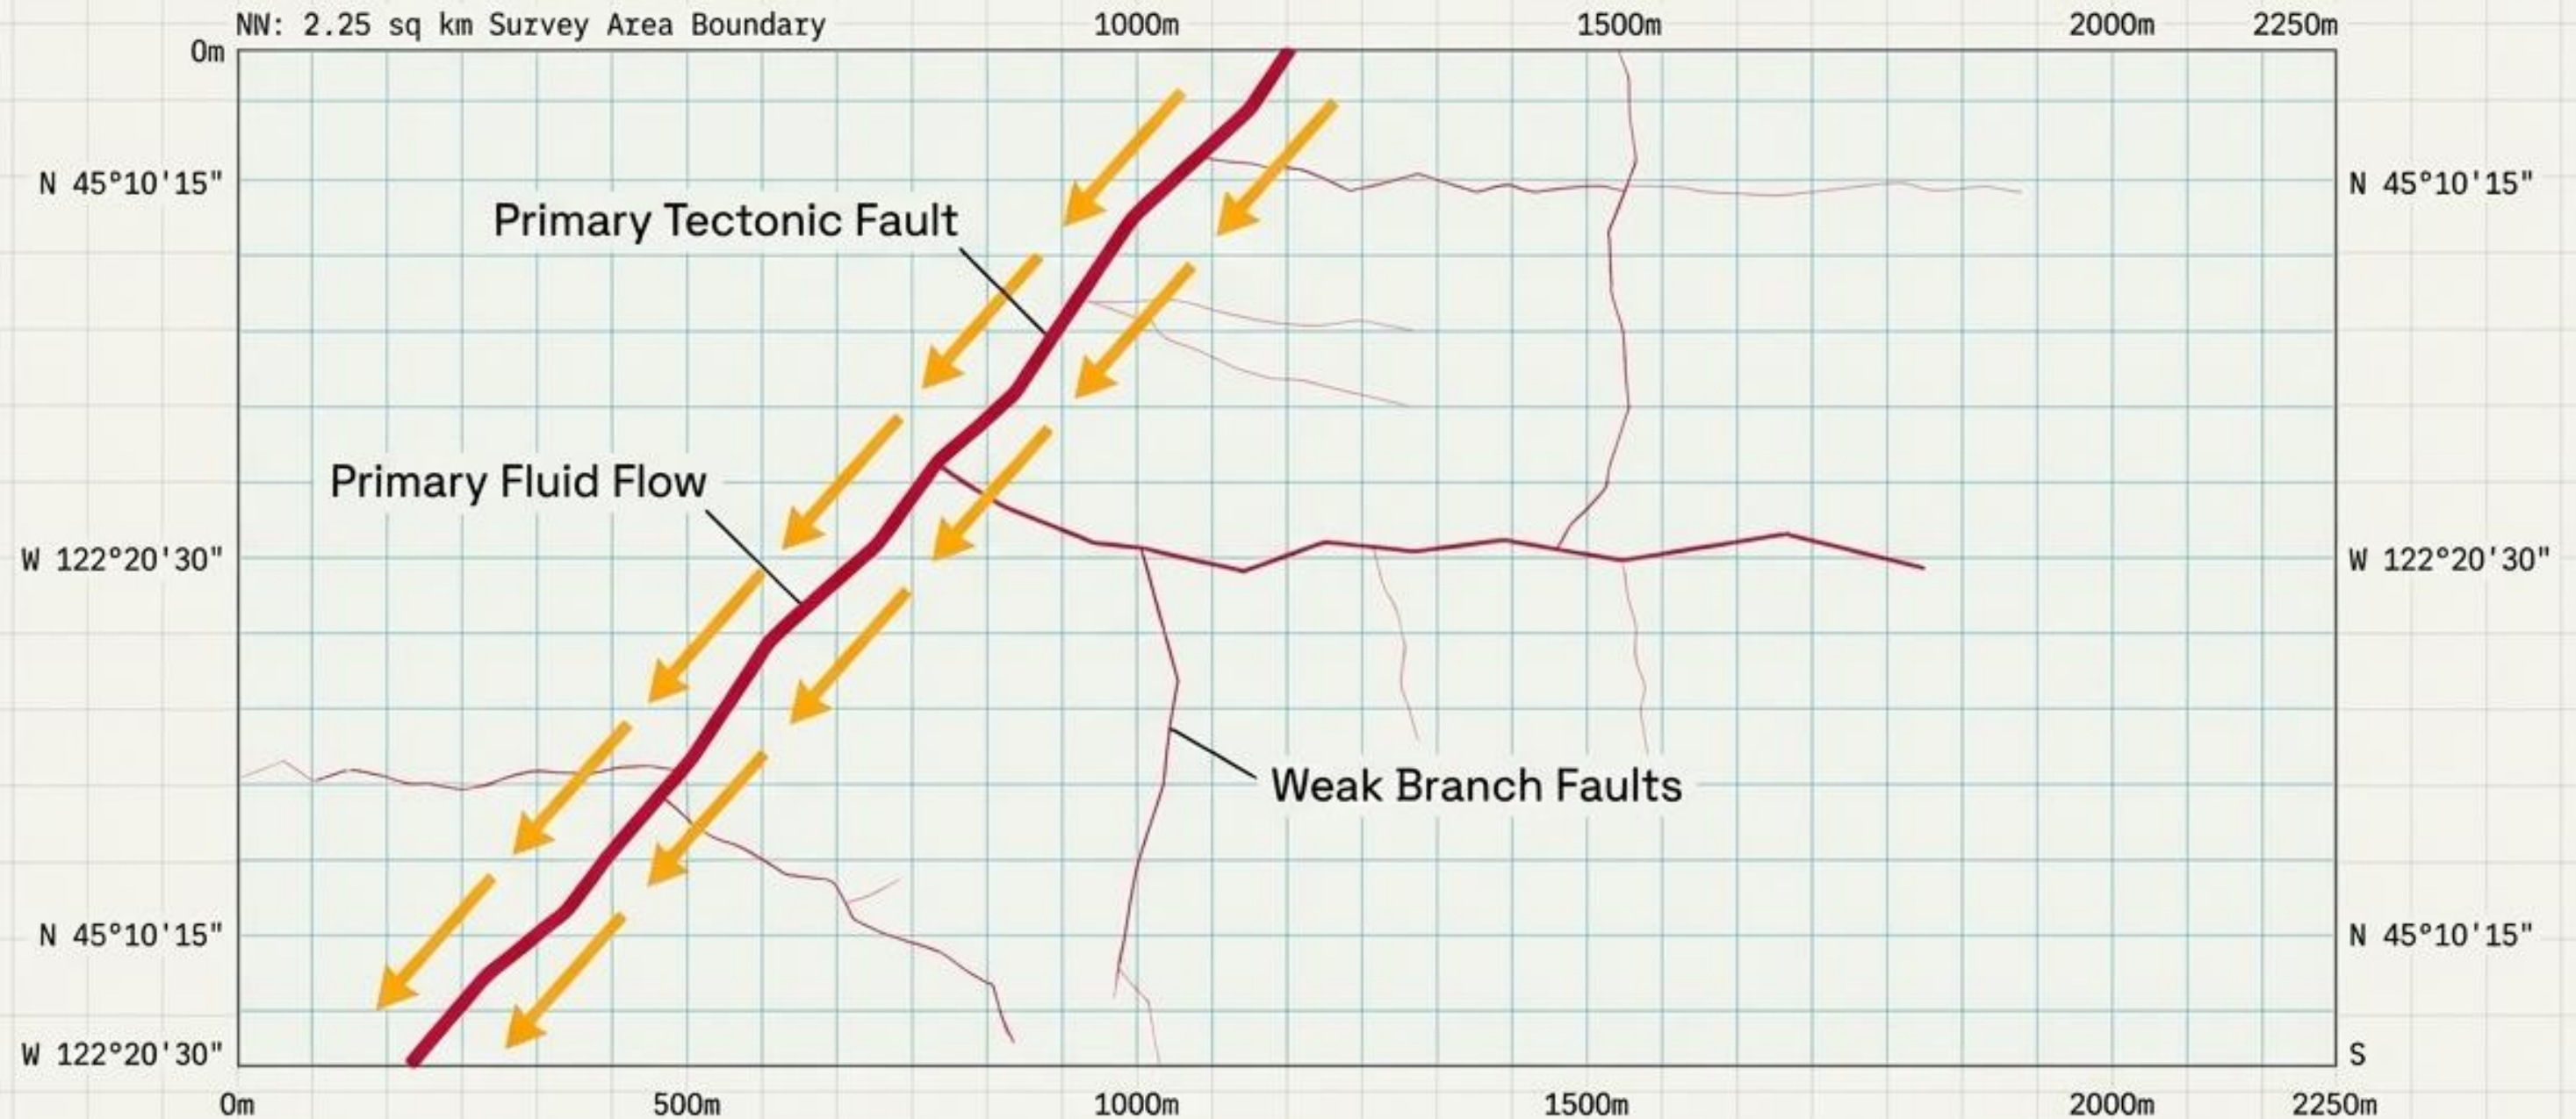
Macro Topography: Tectonic Faults & Fluid Migration

Key Insight: The primary fault dominates the region's subsurface mechanics. While the main fault itself is devoid of hydrocarbons, its weaker branches act as secondary migration pathways.

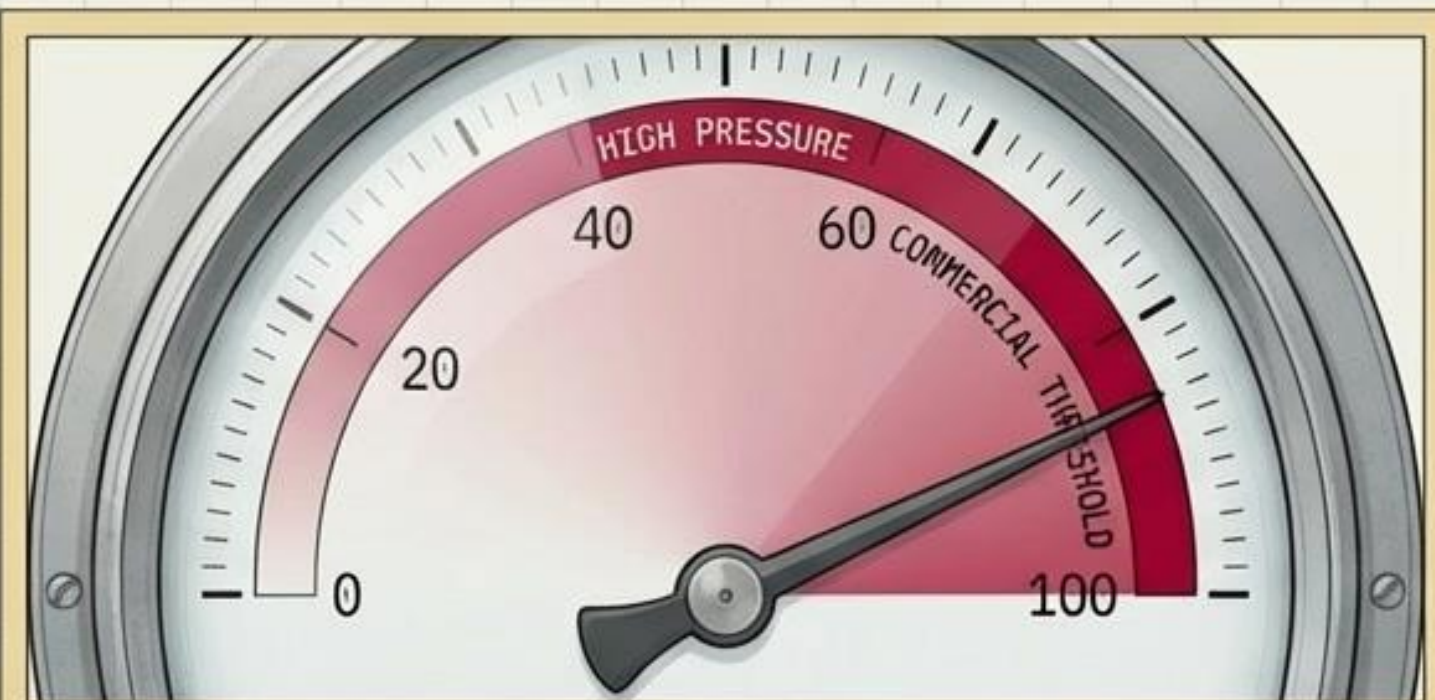
Expected for Commercial Find: Elevated Methane Pressure
